# Analyses of Landscape Design and Maintenance Requirements in Urban Parking Lots<sup>1</sup>

Christina A. Pfeiffer, John A. Wott, and James R. Clark<sup>2</sup>  
Center for Urban Horticulture, GF-15  
University of Washington  
Seattle, WA 98195

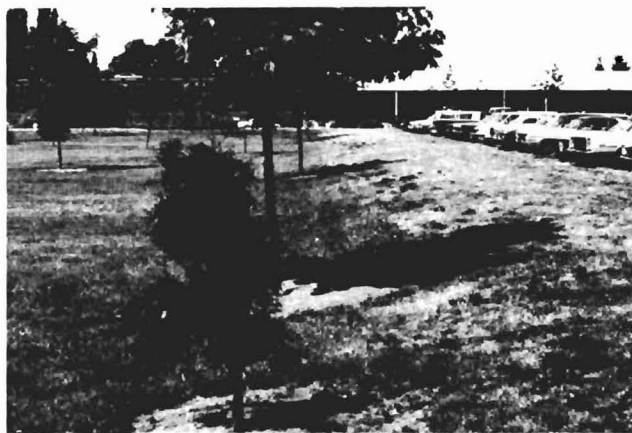
Fig. 2. Soil compaction along a parking lot perimeter. The boundary where grading ended is evident along the light-colored strip adjacent to the parked cars. Eighteen *Thuja plicata* were planted in this strip four years earlier.

Adherence to soil specifications was also variable. Where there should have been a uniform condition, layers of clay were interspersed in the parking island topsoil.

Soil conditions at construction sites have been identified as a major limitation to plant establishment (1, 14, 22, 29, 30, 31). The construction procedures for these parking lots were very destructive to soil structure. Specifications required the subgrade for pavement to be compacted to 95% standard density (37). This translates to a total pore space of 5% and where grading overlapped into planting areas, it had serious consequences for plant establishment. In a perimeter bed at one site, all 18 *Thuja plicata* Donn, Western red-cedar, had died (Fig. 2). Ideally, soils for planting beds should have a pore space of 45 to 50%, with a bulk density of no greater than 1.3 to 1.4 gr/cm (81 to 87 lbs/ft) (29, 31). Correction of soil compaction and interface problems, and the replacement of the missing plants after construction is far more costly than proper soil management during the original construction.

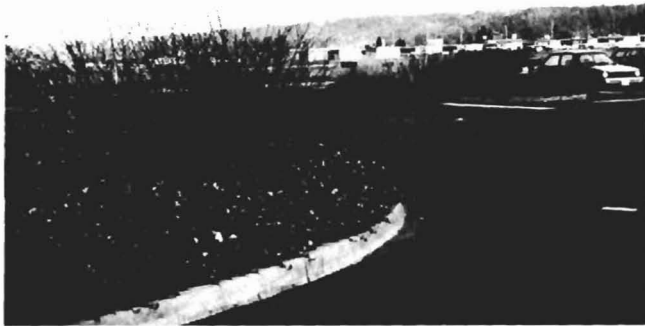
Other species were well-adapted to the site, but were not located appropriately. For example, *Hedera helix* L. 'Baltica,' *Photinia x fraseri* Dress, and either *Cornus alba* 'Sibirica' Loud. or *Cornus sericea* 'Flaviramea' Rehd. were planted together in parking island planters (Fig. 3). *Hedera helix* 'Baltica' requires at least three

Fig. 3. Example of a densely planted parking island bed. The tall heights of *Photinia x fraseri* and *Cornus alba* 'Sibirica' contribute to visibility problems for pedestrians and vehicles. In addition, all the species used require frequent pruning to control their size.

edgings per year in the Pacific northwest, making it a high maintenance choice for island planters and narrow beds. Performance standards for these sites indicated that for safety and visibility, shrubs located within 9 m (30 ft) of an intersection were to be no taller than 0.76 m (2.5 ft) at maturity (27). *Photinia x fraseri* and the two *Cornus* are vigorous plants with rapid growth to over 3.2 m (10 ft) tall and required frequent pruning to maintain the low height. In addition, the *Photinia* were showing trunk dieback from frequent shearing. These shrubs would have been more appropriately used in perimeter beds where their height and spread would be more in scale with the planting space.

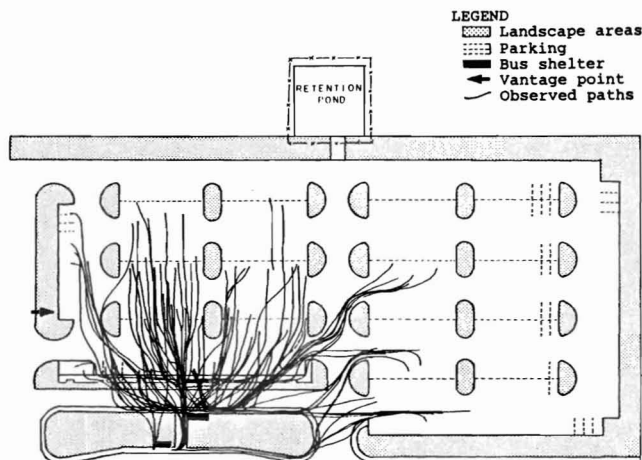
**Human factors.** Pedestrian paths were in radial patterns focusing on the bus shelter area (Fig. 4). Parking spots were filled as a function of nearest distance to the bus stop. People who arrived early tended to follow the paved walkways. However, once a bus arrived, the pace

Fig. 4. Observed pedestrian paths from the parking area to the bus shelter. These paths represent the typical activity of commuters on a normal business day. The pedestrian paths observed for all the lots in this study conformed to a radial pattern as shown for this site.

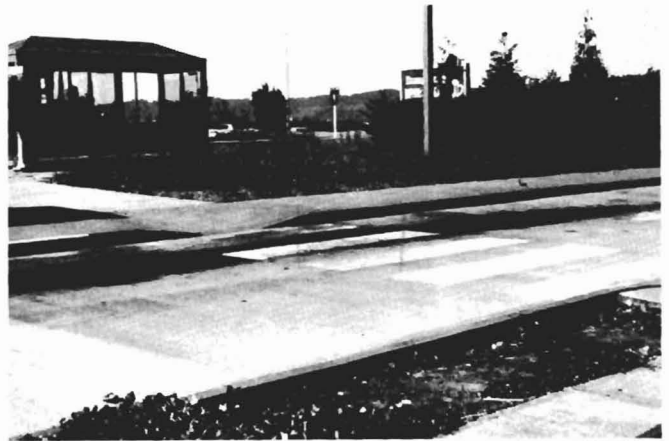
Fig. 5. Physical damage to the planting bed adjacent to the bus shelter directly corresponded to the observed traffic patterns shown in Figure 4. People using the parking lots tended to follow the provided sidewalks until a bus arrived at the stop. Then, they walked directly through any planting beds which intersected direct access to the bus.

quicken to the most direct path, often across a landscape bed. Paths and mechanical damage to planting beds near the bus shelter directly corresponded to the observed pedestrian traffic (Fig. 5). Pedestrian traffic was concentrated near the shelter areas. Designs which provided ample access and walking space around the shelters had less landscape damage and were visually more effective.

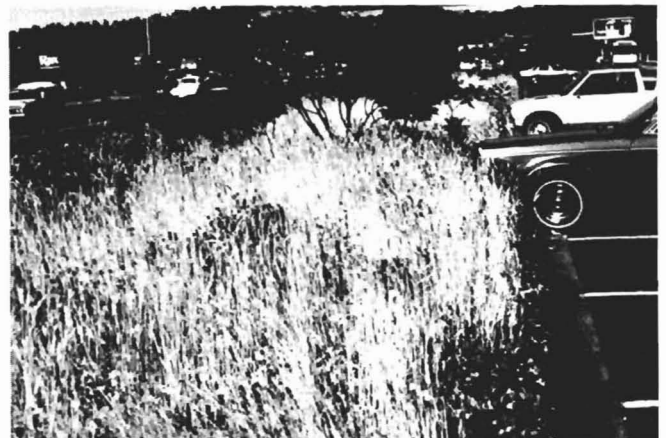
Fig. 6. Dense weed growth in a landscape bed may have contributed to the high mortality of *Rhus glabra* planted there. This problem was likely a combined result of landscape specifications which indicated that herbicides were not to be used, coupled with an inadequate maintenance program after installation.

**Maintenance.** Inadequate maintenance schedules during initial years after installation contributed to many of the plant vigor and mortality problems (Fig. 6). Litter counts indicated that litter clean up would be a required component of the maintenance schedules. Most of the litter items appeared to come from surrounding businesses and fast food chains. Other litter sources resulted
